Known fixes and bulletins

Bulletin

- All models with DW engine.

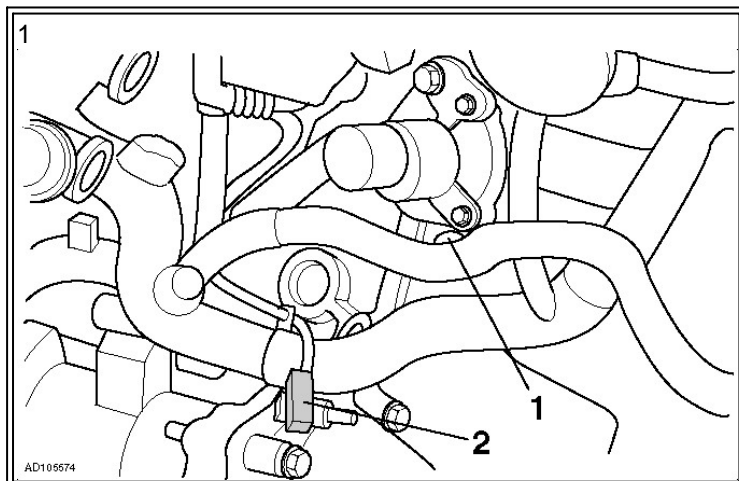
- Engine malfunction indicator lamp (MIL) illuminated.
- Trouble code stored in engine control module (ECM) fault memory: P1641.
- Battery discharges.

- Engine coolant travelling by capillary action into engine control module (ECM) wiring harness from yellow 2-pin engine coolant temperature (ECT) switch connector [Fig. 1](#) [1].
- Engine control module (ECM) failure due to water ingress.

- Fit new engine wiring harness.
- Disconnect yellow 2-pin engine coolant temperature (ECT) switch connector [Fig. 1](#) [1]. Insulate using dummy connector [Fig. 1](#) [2].
- Fit new engine control module (ECM).
